Manhole Inspection Summary

Manhole # S25GG_043MH

Location Address: **1813 BRUNT ST**

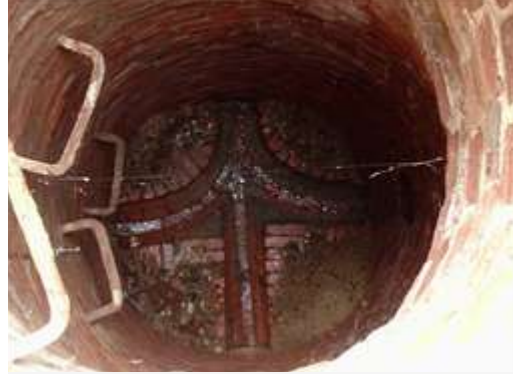
Top View

Corroded steps. Bench debris.

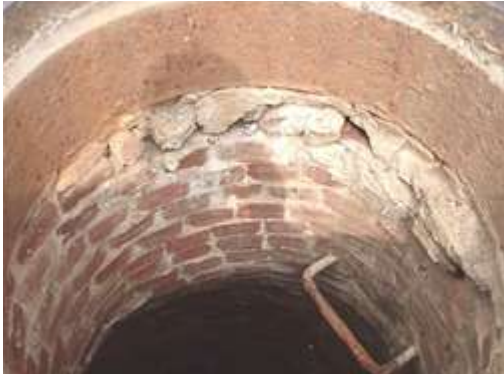
Defect

Frame leaks. Adjustment deterioration, loose brick and infiltration. Barrel infiltration - other side.

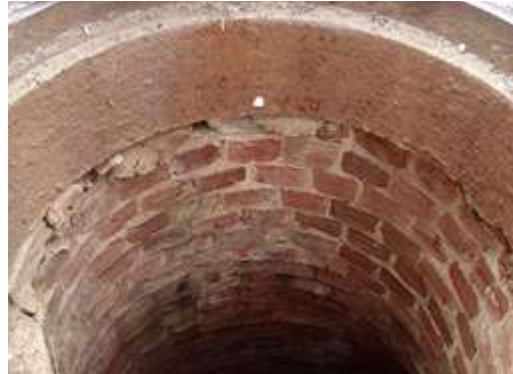
Defect

Frame leaks. Adjustment deterioration, loose brick and infiltration. Barrel infiltration.

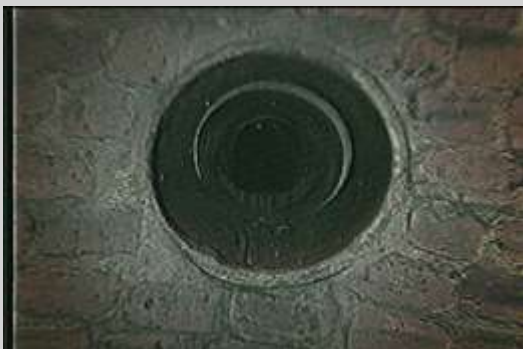
8 in. Circular Gravity Sewer Pipe In @ 3 O'Clock

Deposits: ☐ None ☐ Mud ☐ Sludge ☐ Debris ☒ Grease

Silt Depth: **0** (in.) Deposits Extent: **Light**

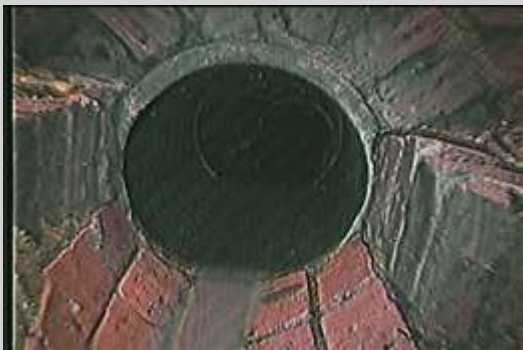
Pipe In @ 9 O'Clock

Channel deterioration.

Infiltration: **None** Pipe Seal Cond: **Cracked**
